Manhole Inspection Summary

Manhole # S23M__023MH

Insp Date: **5/7/09 11:12 AM**

Location Address: **1519 COLE-EAGLE-ALLEY**

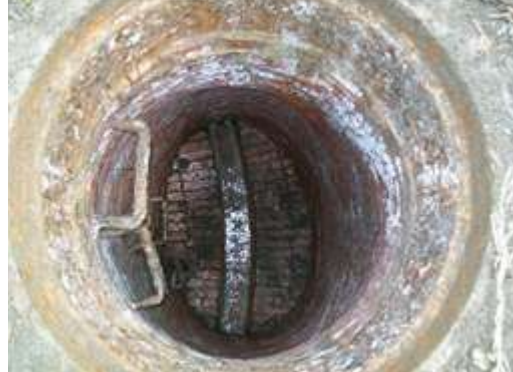
Defect 1

Condition: ☐ Sound ☐ Cracked ☐ Root Intrusion ☐ Loose Brick ☒ **Deteriorated**

Infiltration: ☐ None ☒ **Joint** ☐ Cracks ☐ Mortar ☐ Roots ☐ Wall

Corbel Deteriorating, Joint Infiltration in Corbel, Frame Leaks, Corroded Steps

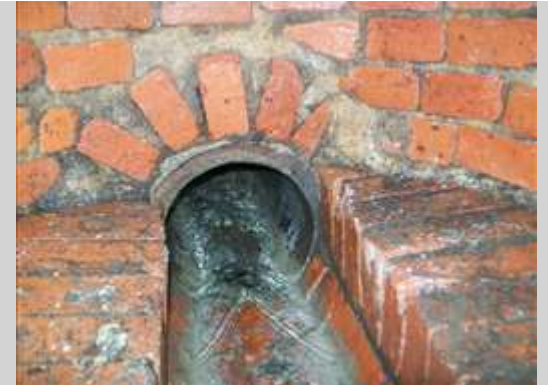
12 O'Clock Outflow

8 in. Circular Gravity Sewer
Pipe Out @ 12 O'Clock

Infiltration: **None** Pipe Seal Cond: **Sound**

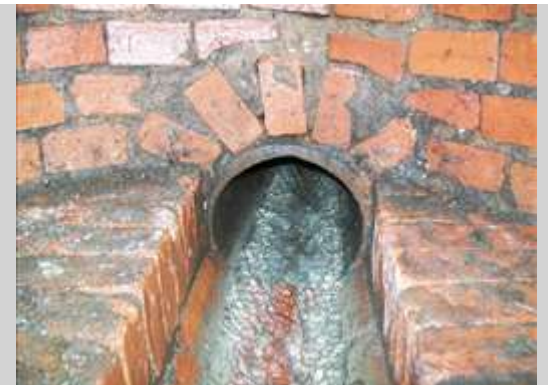
7 O'Clock Inflow

8 in. Circular Gravity Sewer
Pipe In @ 7 O'Clock

Infiltration: **None** Pipe Seal Cond: **Sound**
